Navajo Abandoned Uranium Mine

Site Screen Report

Mine Name: **Edward Steve No. 1**Mine ID: **84**

August 2011

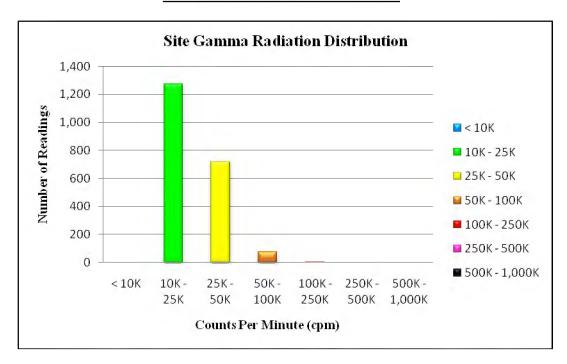
Highest gamma radiation measurement: 103,910 counts per minute (cpm)

Background Average: 13,791 cpm **Two Times Background:** 27,582 cpm

A total of 2,067 gamma radiation measurements were collected from the mine site, ranging from 11,742 cpm to 103,910 cpm. Measurements collected in the vicinity of the waste rock were found at a maximum level of approximately 100,000 cpm, and the workings of approximately 30,000 cpm. The measurements are represented in Figures 1 and 2.
